# Project Completion Report

## Reline of Leaking GRP Sectional Tank

### Frimley Park Hospital - London

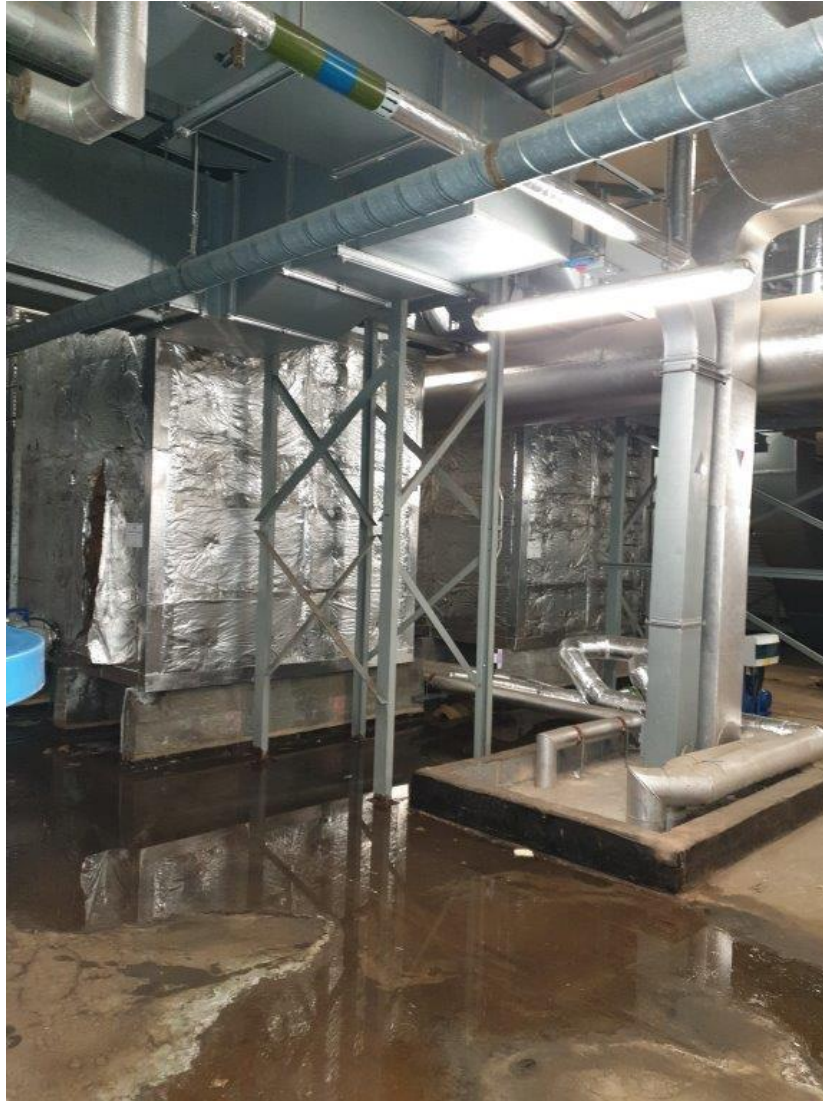
The photo below shows the extent to which the cold-water storage tank was leaking, causing major operational difficulties in the plant room area:

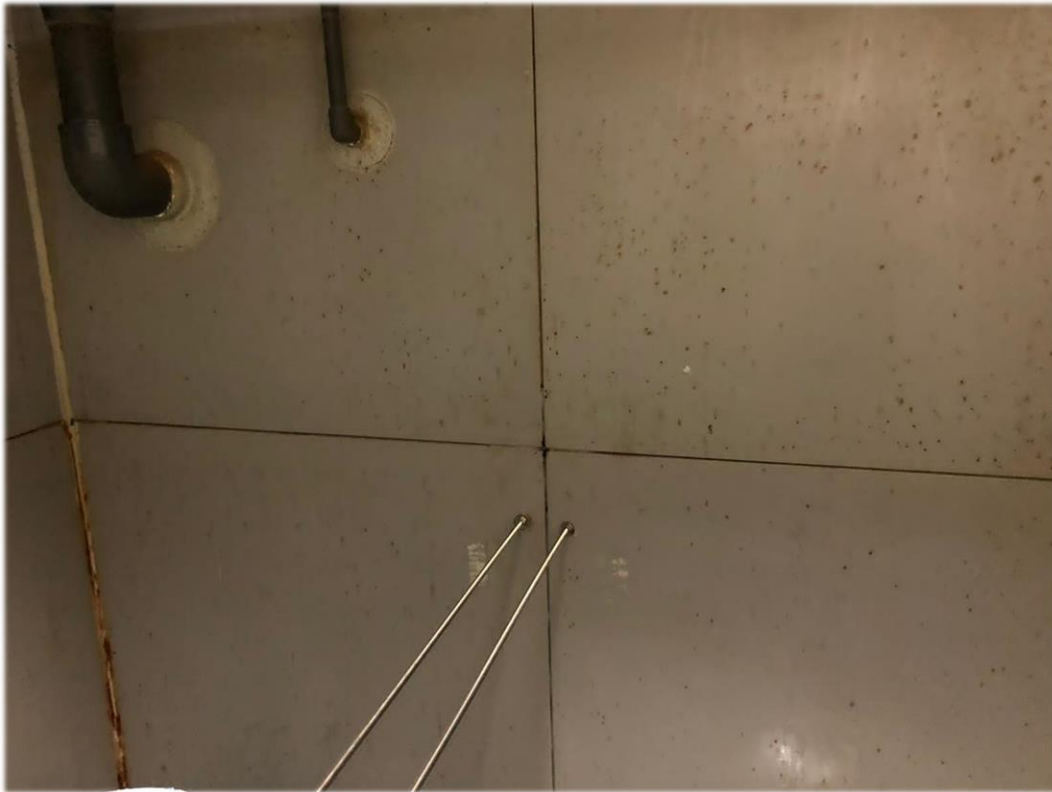
CWST was in poor condition prior to preparation, with clear evidence of debonding in the mastic, and delamination of the GRP surface.
