# Project Completion Report Tank Replacement Holiday Park, Loch Lomond

**Project Brief:** One GRP cold water storage tank located outside of the garage is currently leaking and with damaged panels. Replace current tank with a new sectional GRP cold water storage tank to maintain compliance.

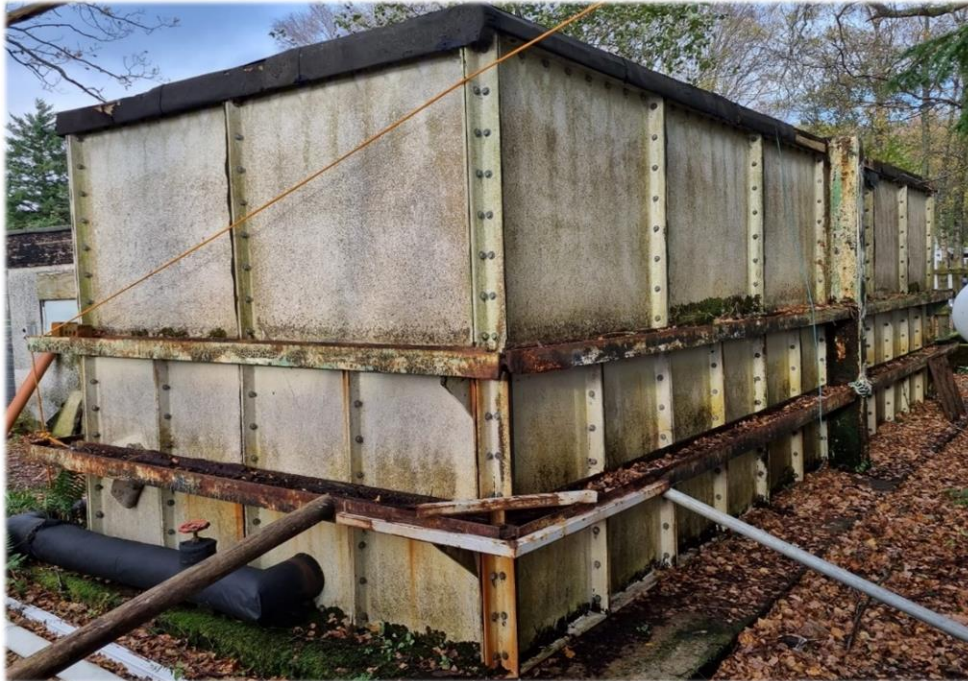
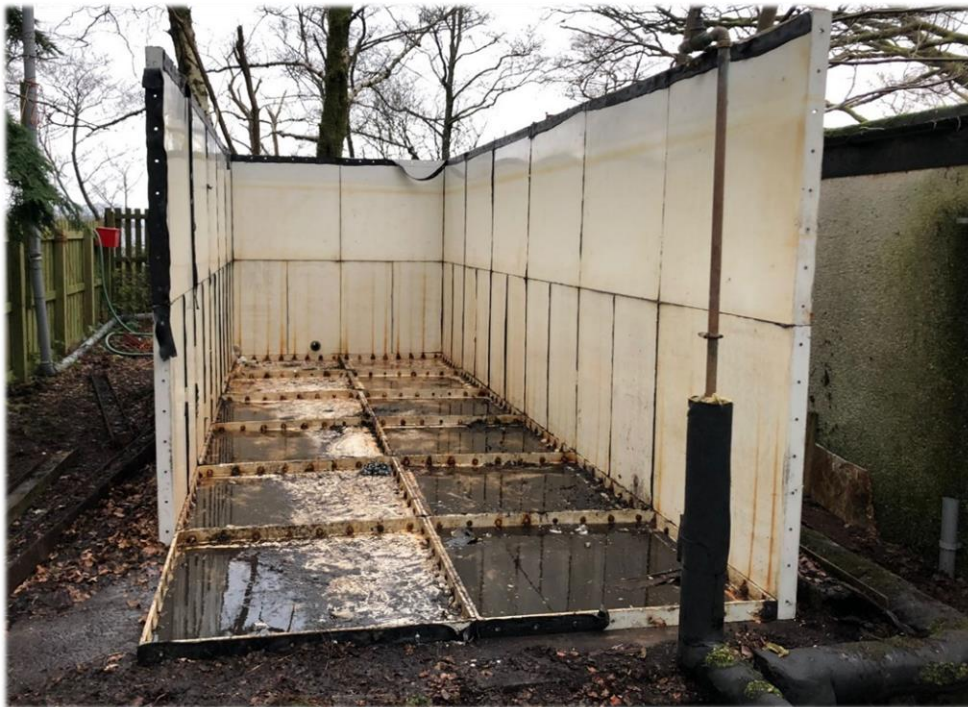
The photos below show before and after 1no tank was replaced with a new sectional GRP cold water storage tank.

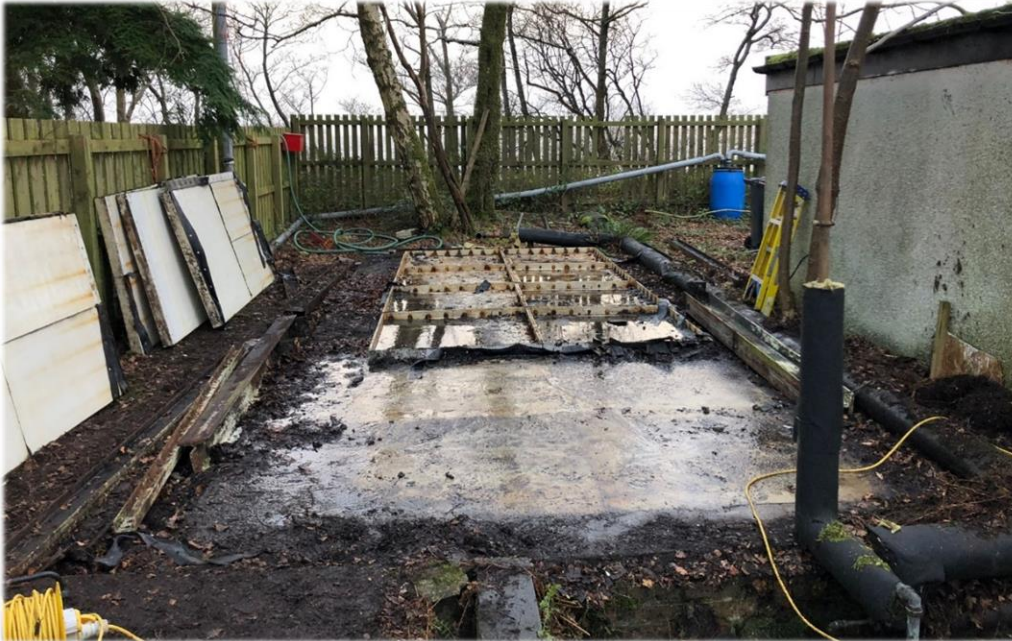
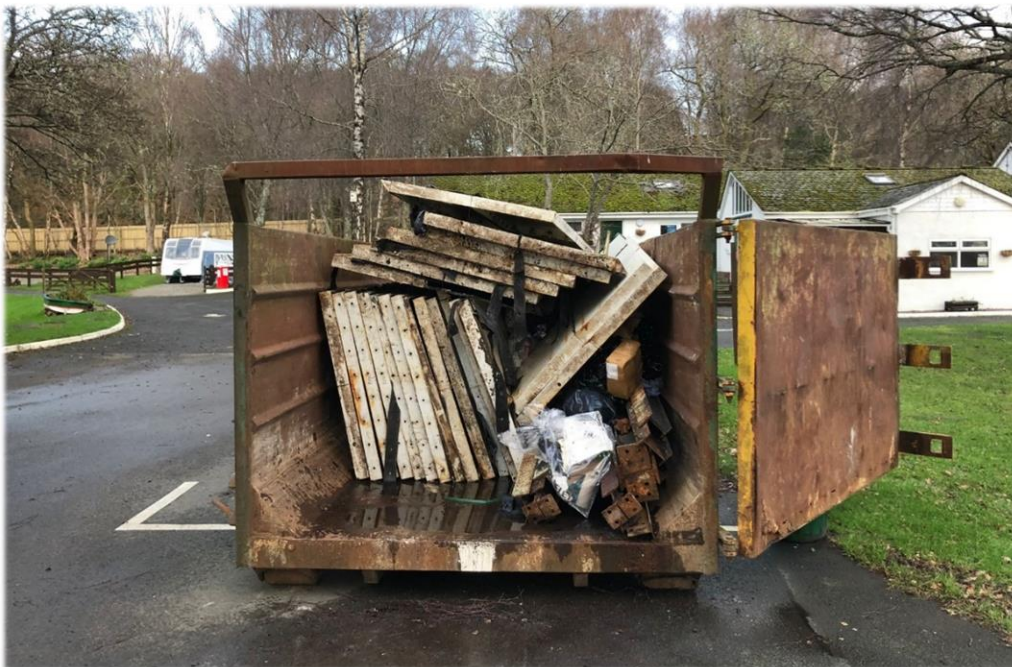
The photos below show the various stages of the tank replacement process.

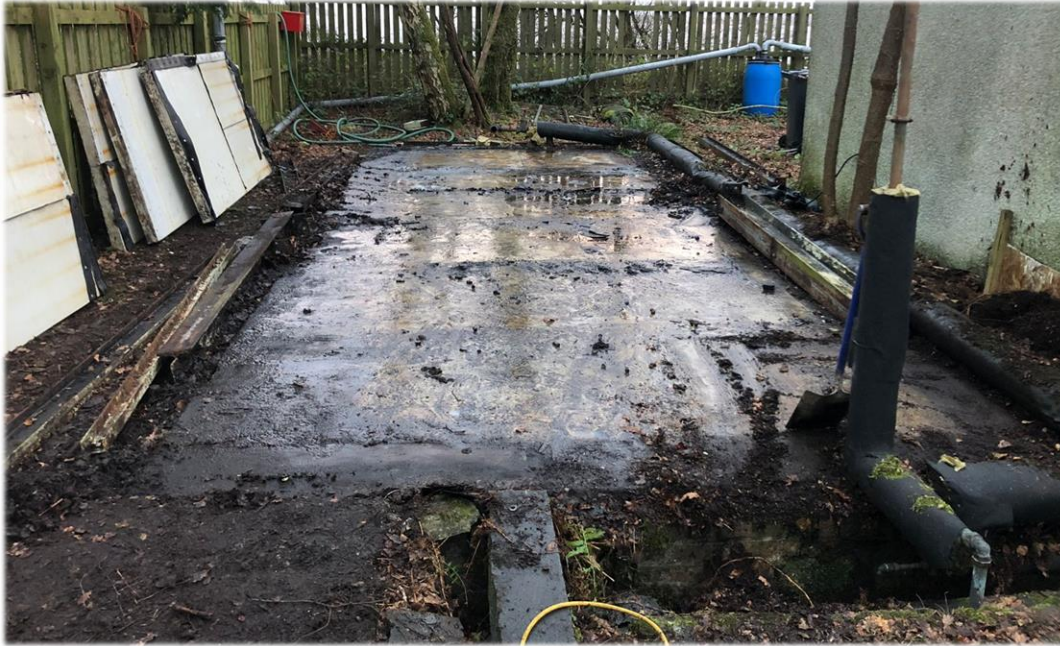
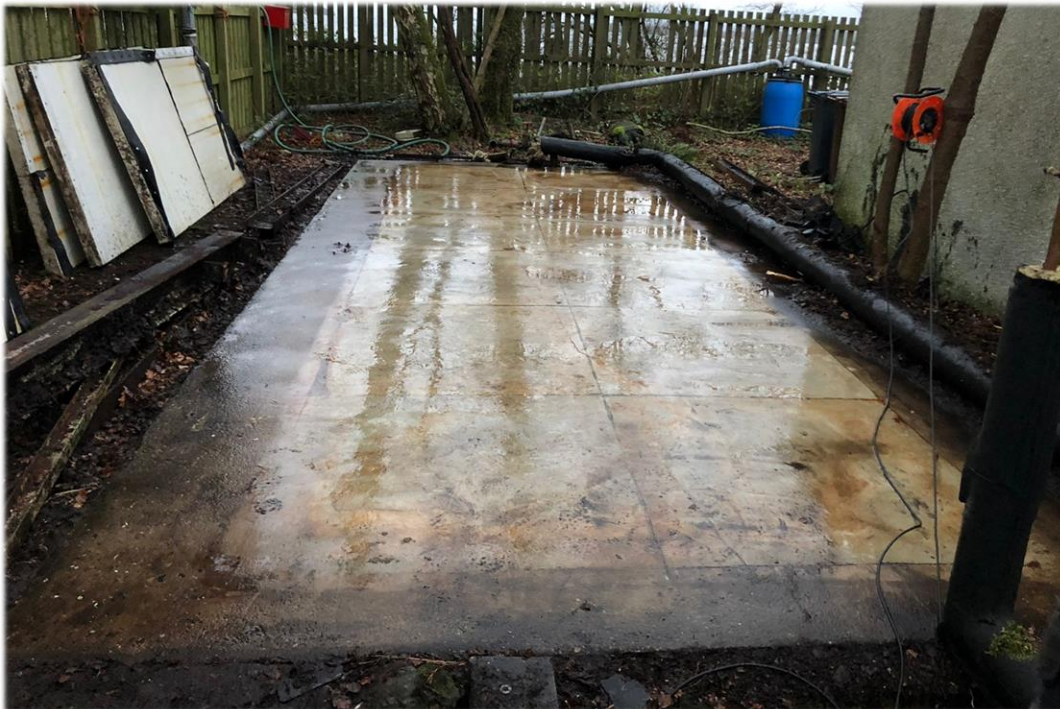
The photos below show the various stages of the tank replacement process.

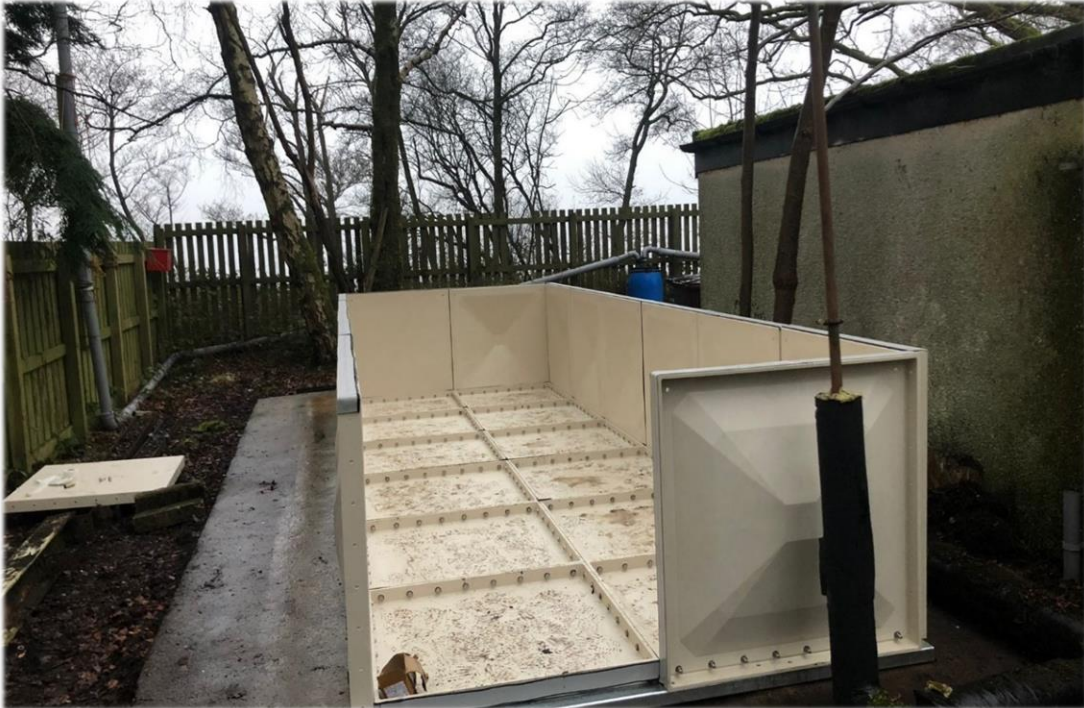
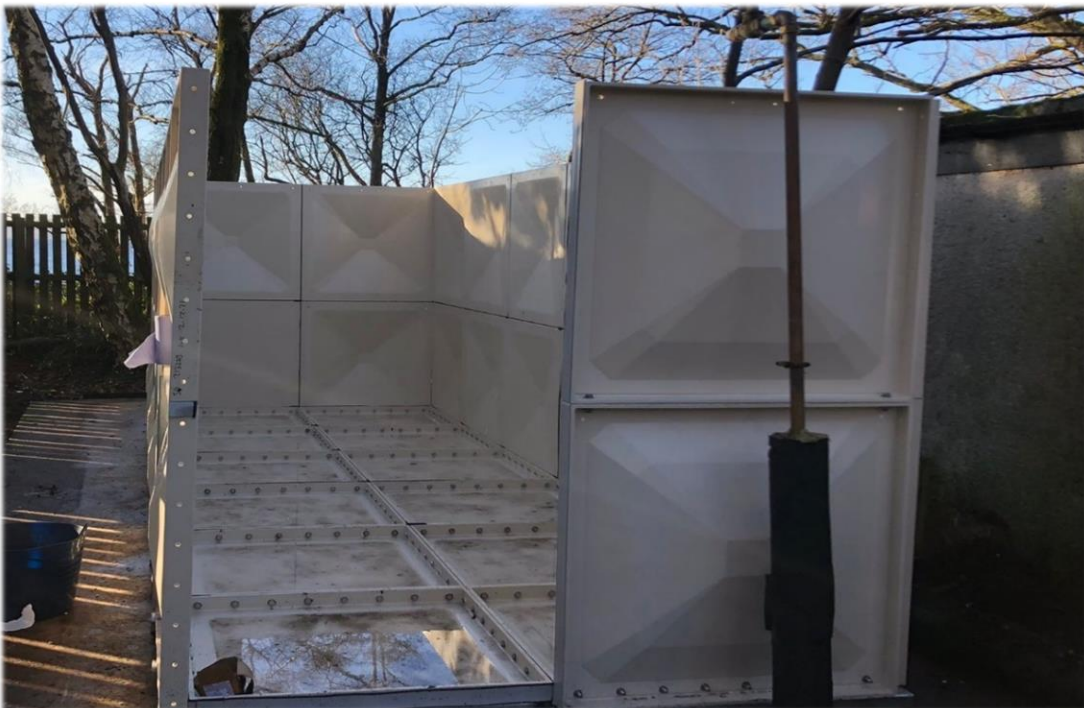
The photos below show the various stages of the tank replacement process.

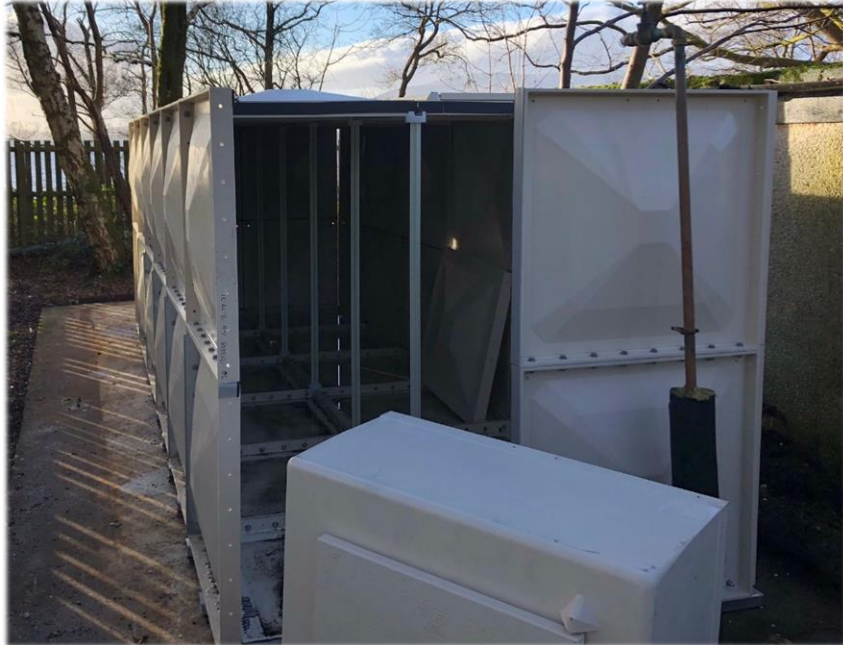
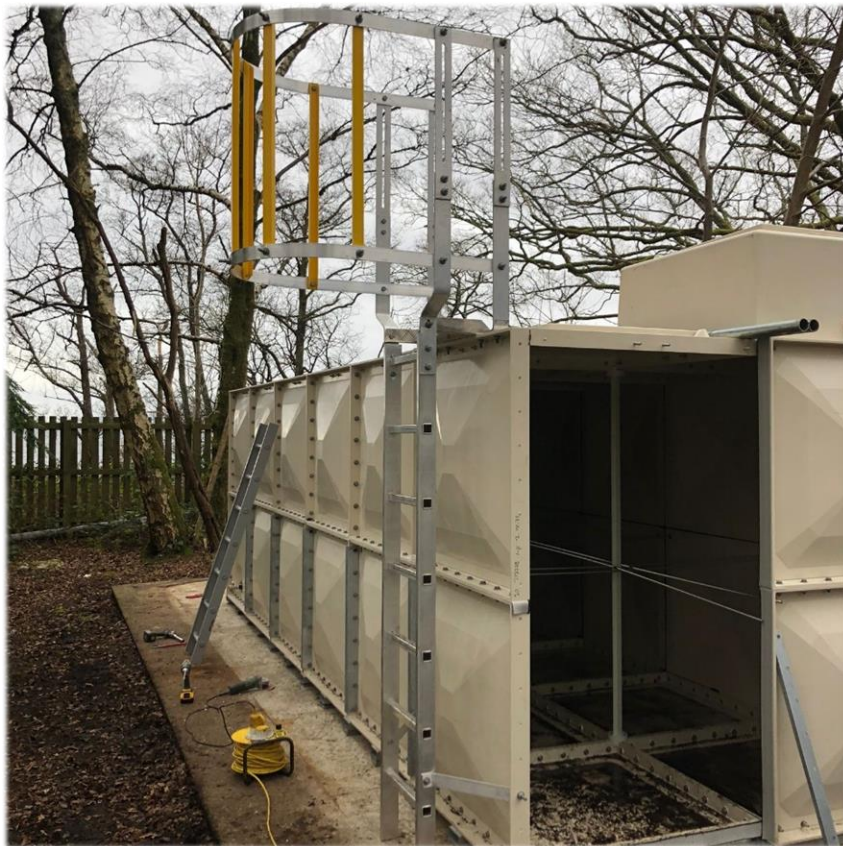
The photos below show the various stages of the tank replacement process.

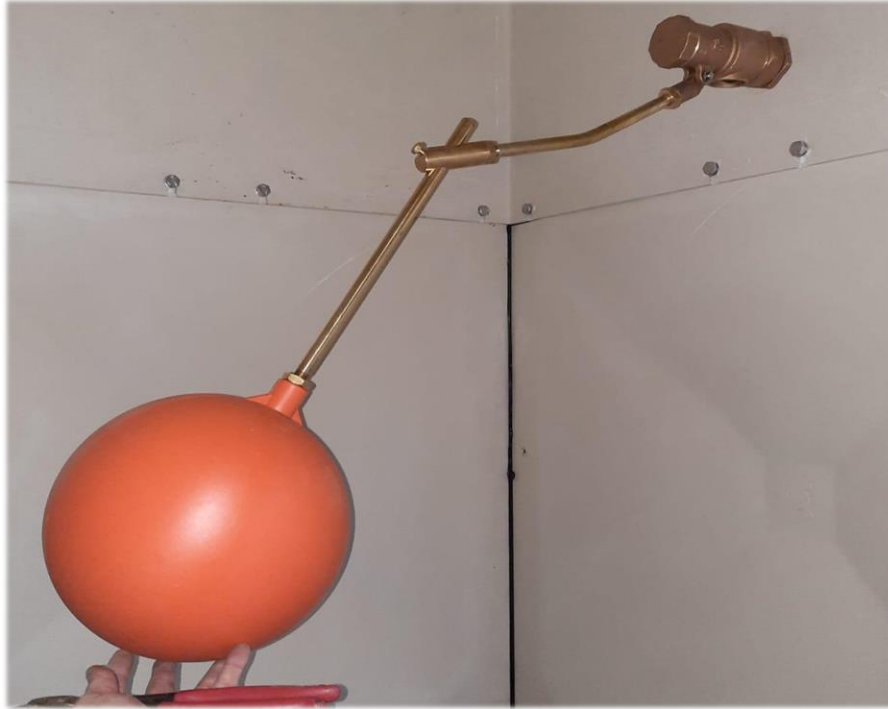
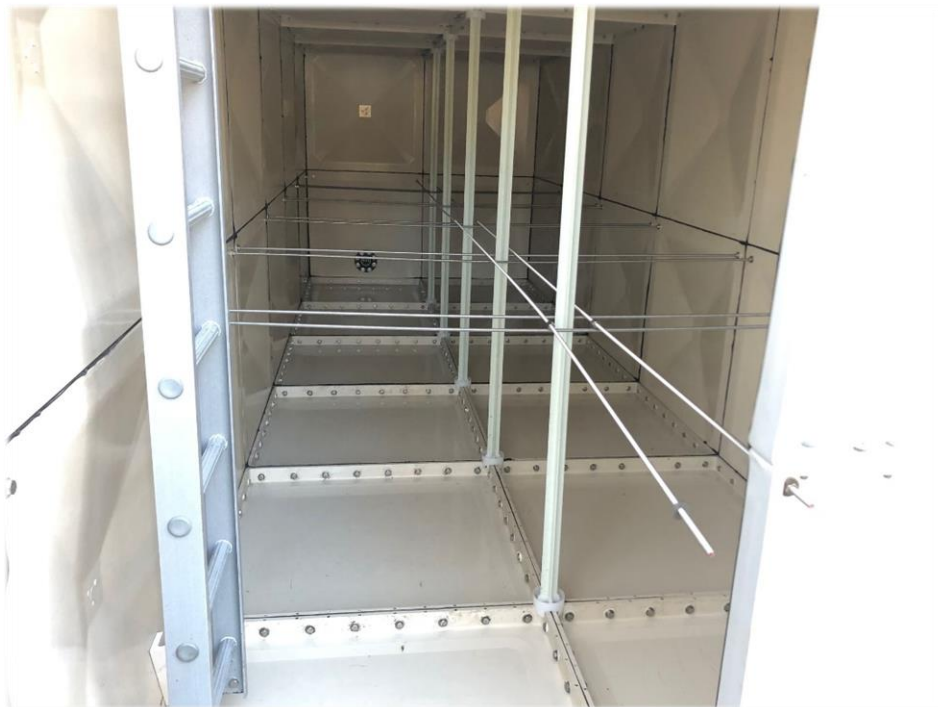
The photos below show the various stages of the tank replacement process.

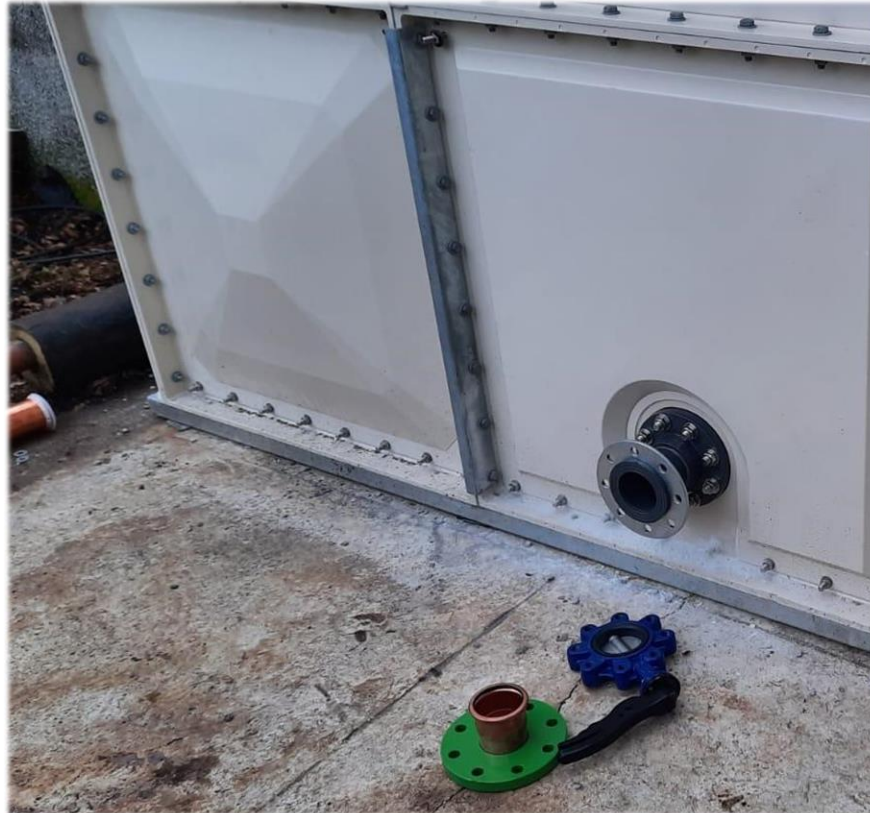
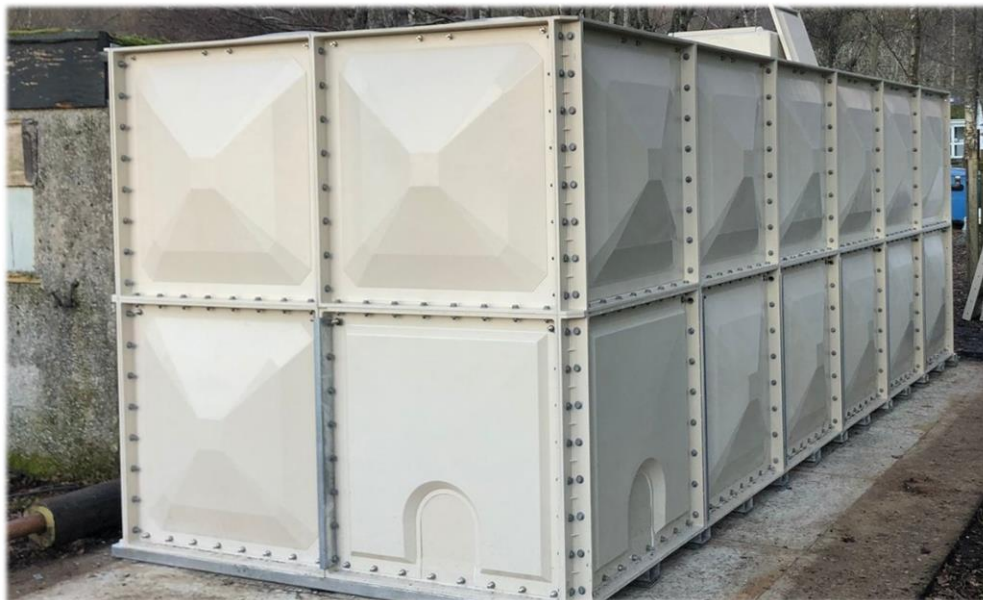
The photos below show the various stages of the tank replacement process.

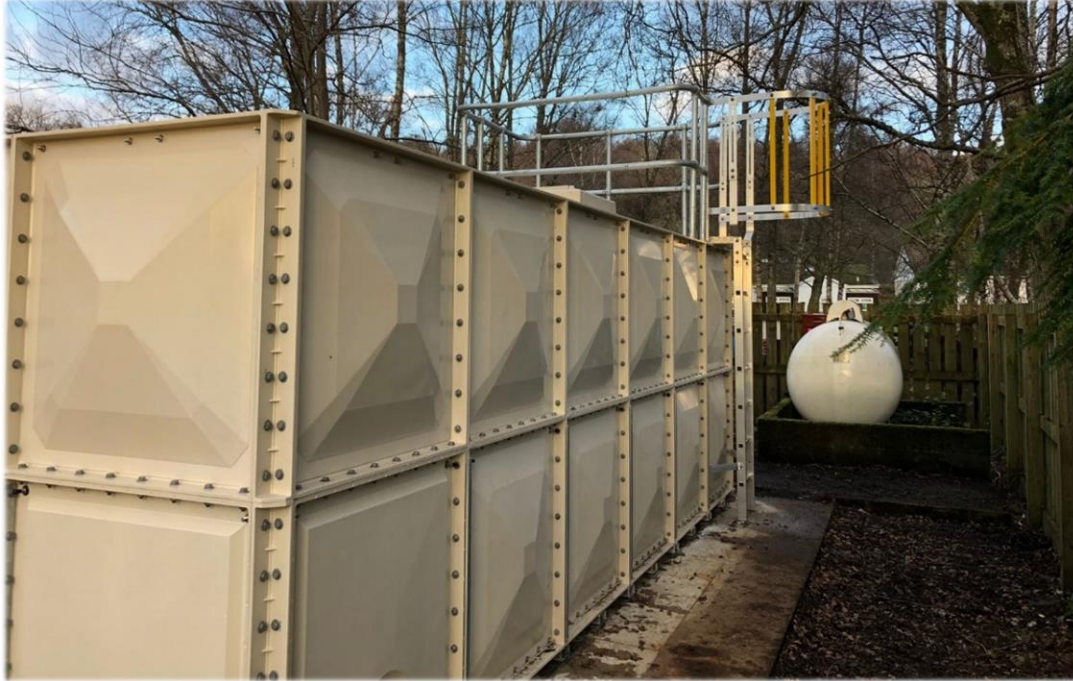
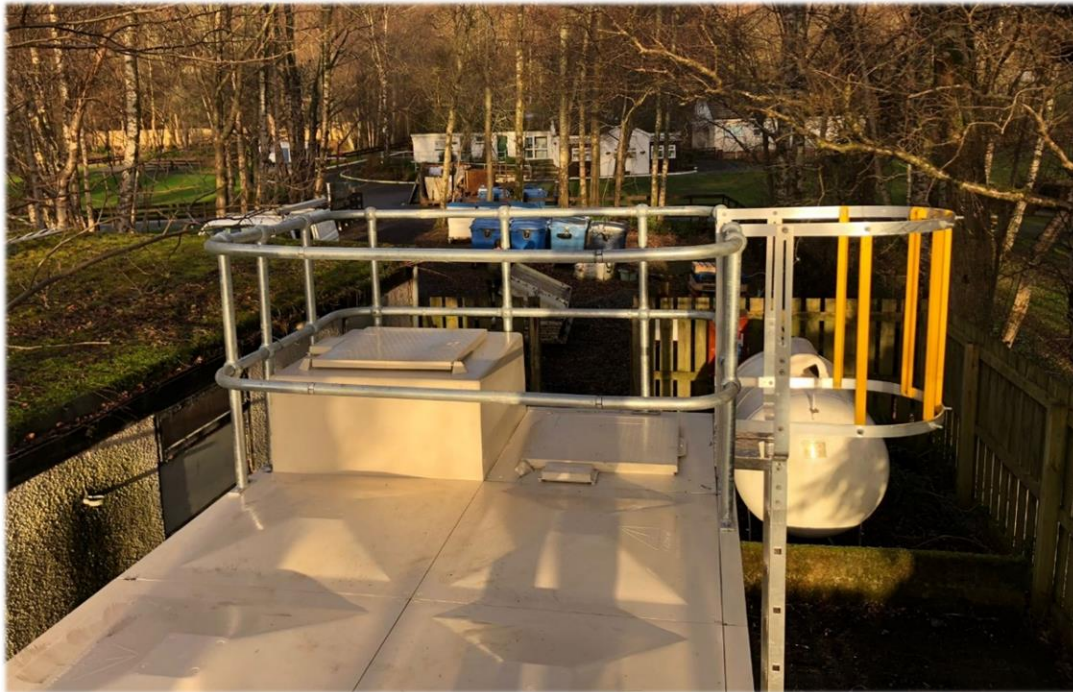
The photos below show the various stages of the tank replacement process.

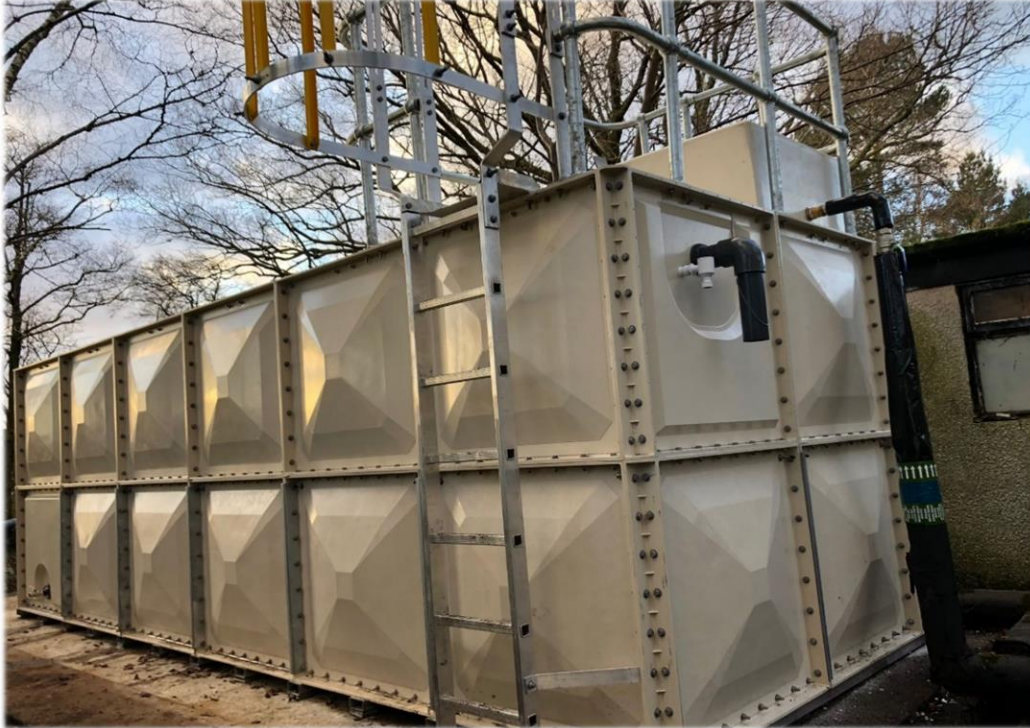
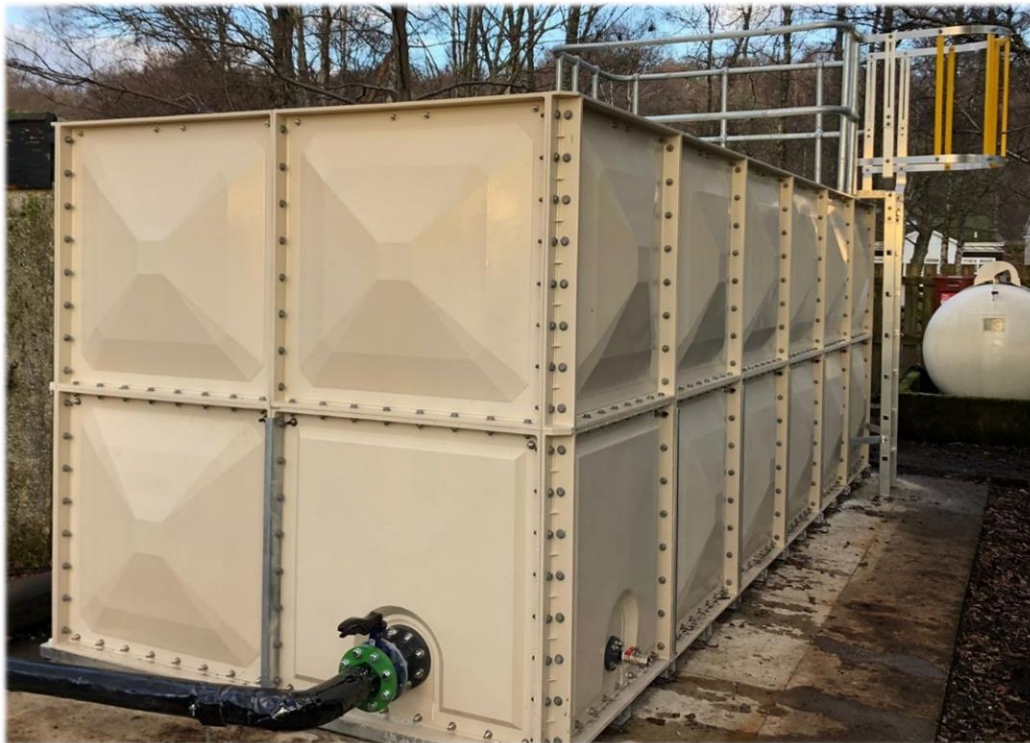
The photos below show after the installation of 1no sectional GRP CWST was complete.
