Project Completion Report

Reline of Sprinkler Tank

Shopping Centre - Manchester

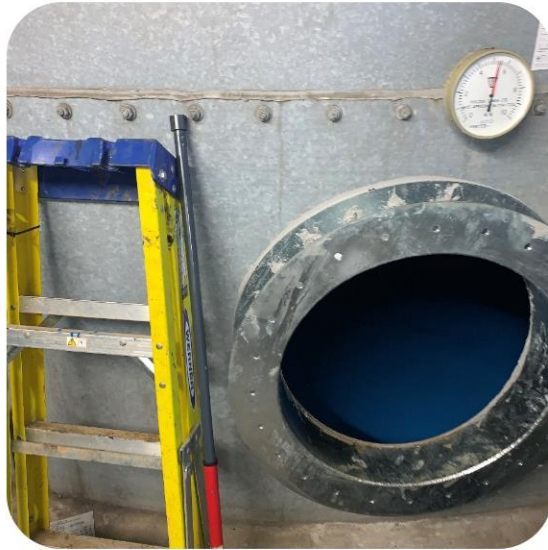
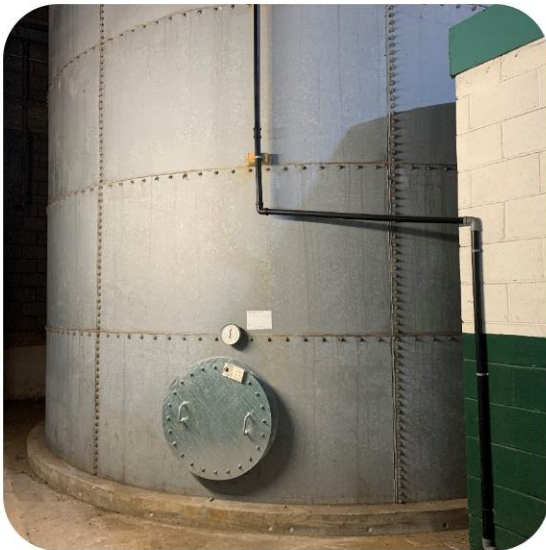
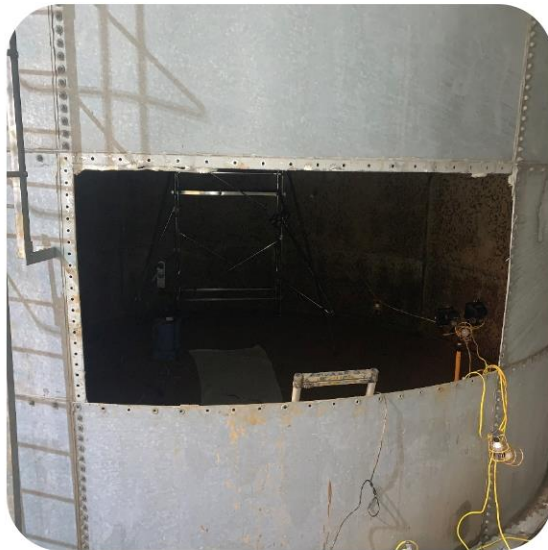
The photos below show the installation of a new low-level access hatch to allow safe access and egress.

- Upon arrival, tanks to be drained down by Titan Mechanical Services - **Complete**
- A low-level access hatch is to be installed to allow easy access and egress from the tank. - **Complete**

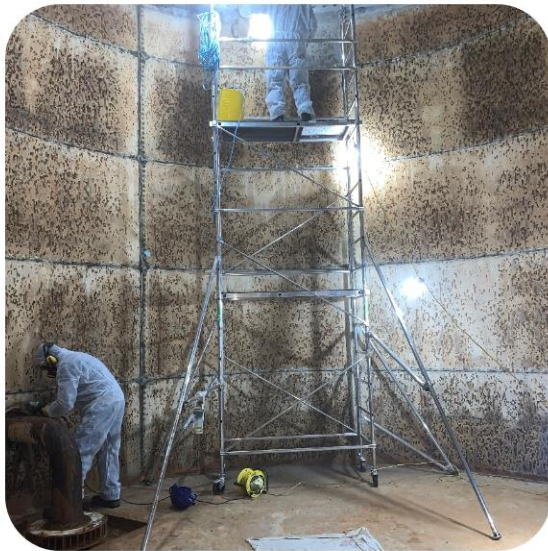
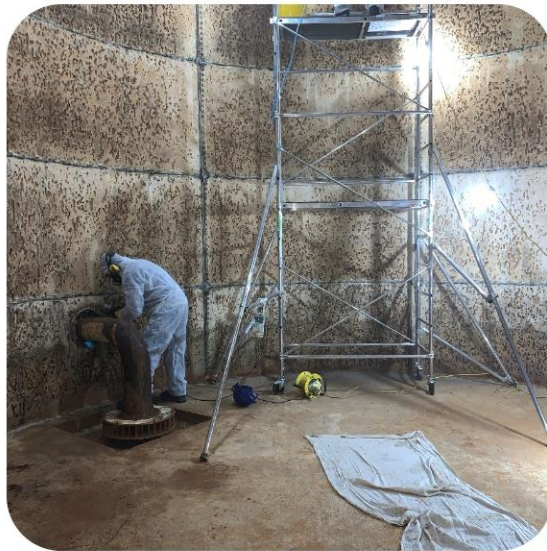
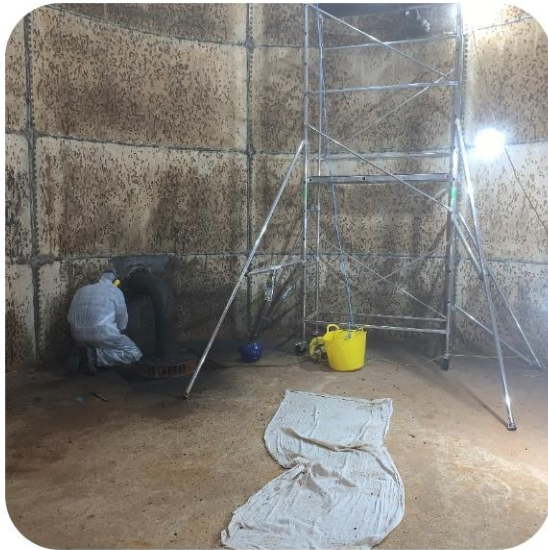
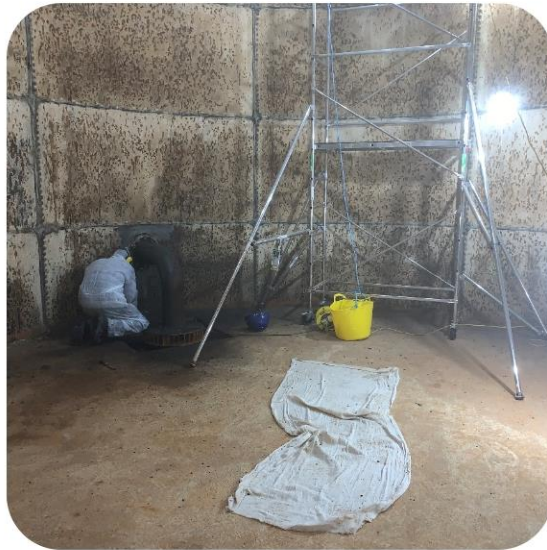
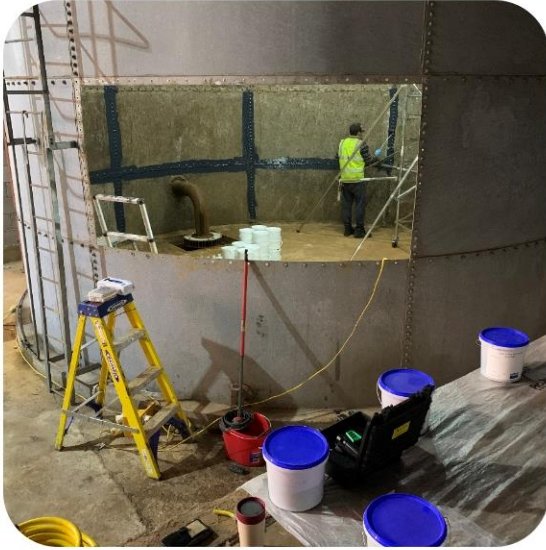
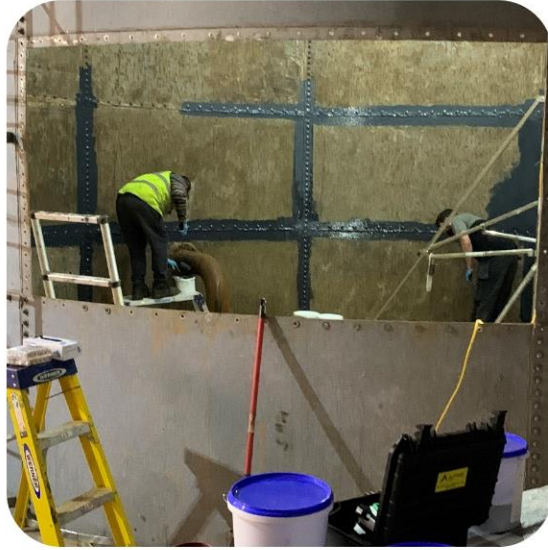
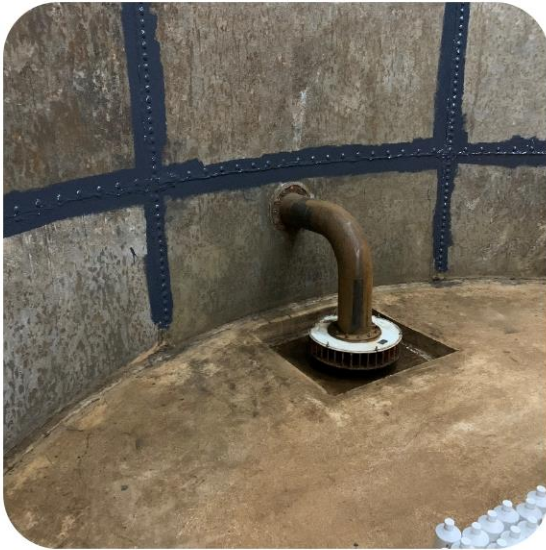
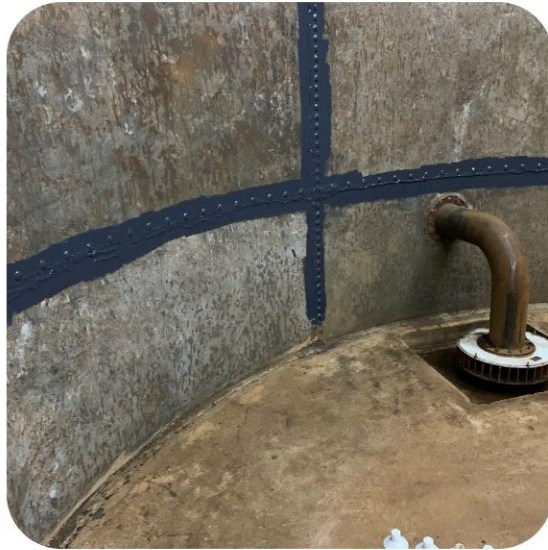
The photos below show the tank at various stages of the process, from preparation of the surface to the final application of the 2nd coat.

- Surface Preparation, the concrete base will be screeded and sealed to repair any defects in the concrete prior to relining works. All accessible bolts to be tightened, mastic joints assessed and repaired where necessary. All surfaces will be abraded to raise a surface profile of ~75microns - **Complete**

- Application of Stripe Coat - the product to be applied by brush to all joints, edges, bolt heads, struts and other sharp protuberances to ensure any high-risk areas are secured and enable subsequent coating to be a seamless membrane - **Complete**

- Application of First Coat - the product to be applied by roller to all internal surfaces to a minimum 500-micron wet film thickness - **Complete**
- Application of Second Coat - the product to be applied by roller to all internal surfaces to a minimum 500-micron wet film thickness to achieve a desired 1000-micron total coating thickness on all internal surfaces - **Complete**
